Streambank Erosion

STREAM NOTES 2 ~ STREAMBANK EROSION

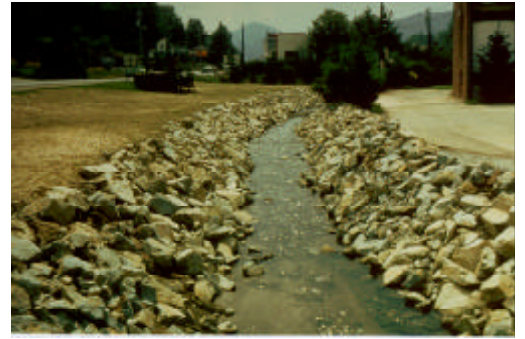
A. Riprap solves the erosion problem at the expense of the stream's natural beauty.

Many of the traditional methods for dealing with streambank erosion have been expensive to install and maintain. Solutions such as rock riprap [fig. A] or gabions (wire baskets filled with rock) may solve the erosion problem, but do so at the expense of habitat and a stream's natural beauty. Today

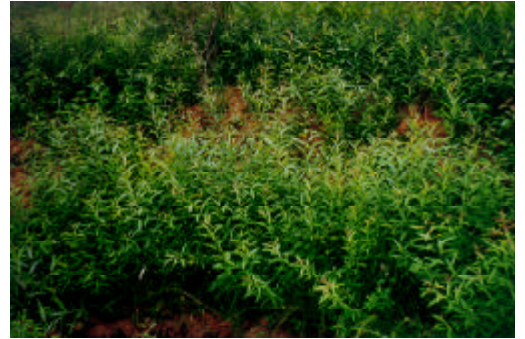
B. Bioengineering uses plant material in a structural way to stabilize eroding banks.

Bioengineering uses plant materials in a structural way to reinforce and stabilize eroding streambanks. This technique relies on the use of dormant cuttings of willows, shrub dogwoods and other plants that root easily. [fig.B] Bioengineering practices range from simple live stakes to complex structures such as fabricated lifts incorporating erosion control blankets, plants and compacted soil.

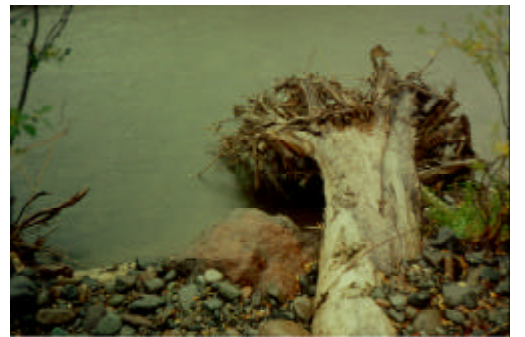
C. Rootwads armor the bank, deflect flow and create fish habitat.

These practices use native materials, wood and stone, to armor streambanks and deflect flow away from them. Low rock walls and log cribwalls can be used to armor the bank. [fig.C] Rootwads armor the bank and provide protection downstream by deflecting the flow away from the bank.

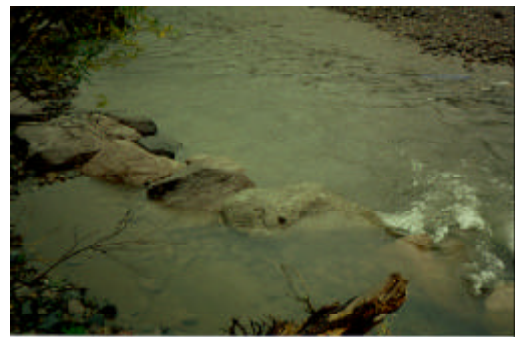
D. Rock vanes deflect the force of the stream away from the streambank.

Rock and logs can be used to construct a variety of structures that stabilize the streambed and banks. Cross vanes are rock structures that stabilize the streambed while aiding in streambank stabilization. Rock or log vanes redirect stream flow away from the toe of the streambank and help to stabilize the bank upstream and downstream from the structure. [fig.D]
